Capital City Home Inspections, LLC
Your Property Inspection Report

Sample Report, Sun Prairie, WI
Inspection prepared for: Marc Schrader
Real Estate Agent: Marc Schrader -

Date of Inspection: 10/2/2017 Time: 9:00 AM
Age of Home: 1972 Size: 3400
Weather: 74 F, cloudy
Order ID: 8089

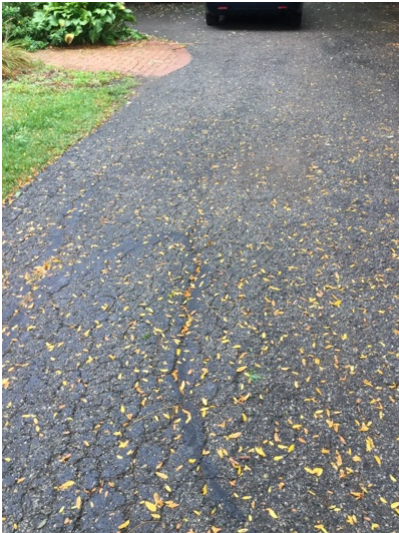
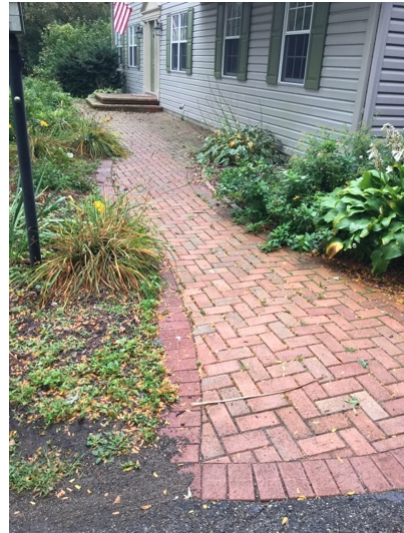
There are minor predictable and common cracks in the asphalt. Monitor these areas for further movement or expansion and repair/seal as needed.

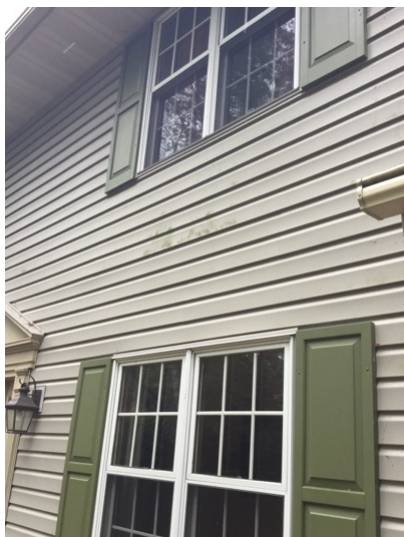
clean the siding...

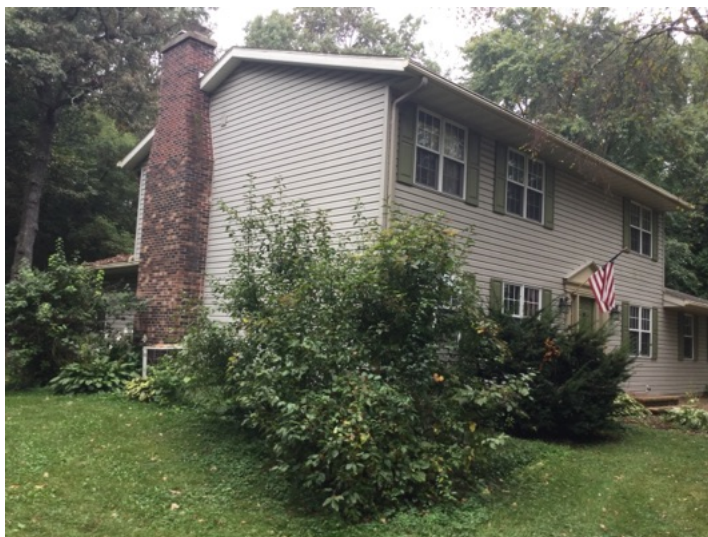
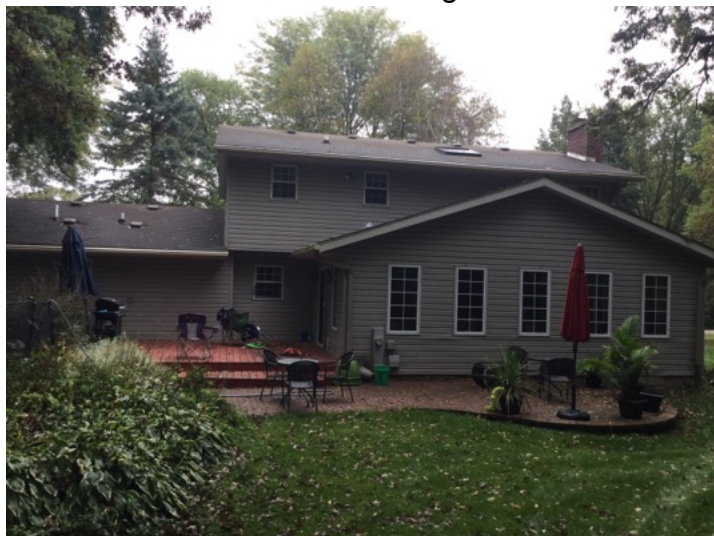
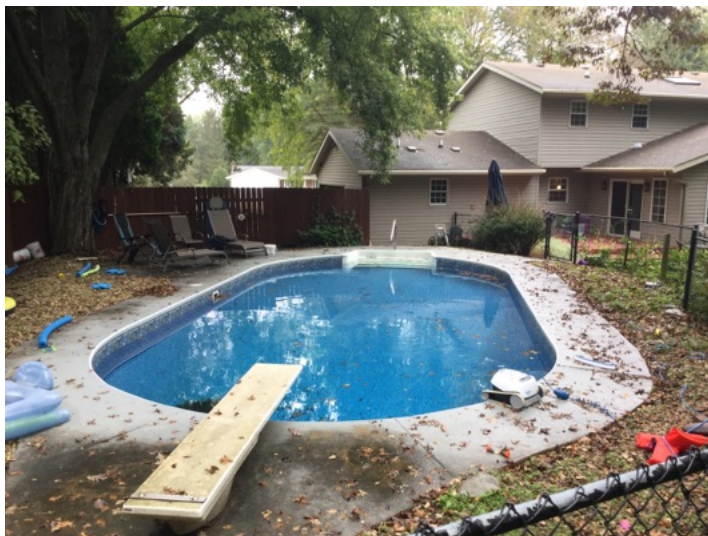
3.3. All siding requires periodic cleaning and some of the siding on the house was noted as needing to be cleaned.

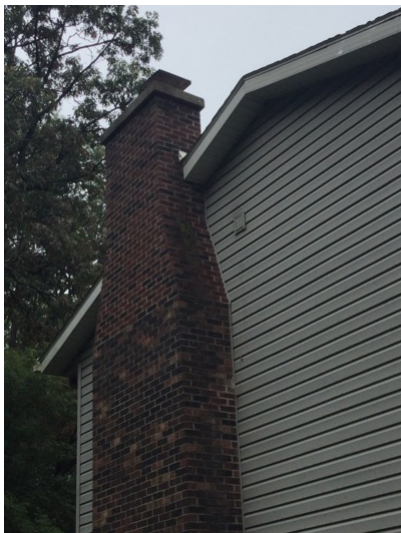
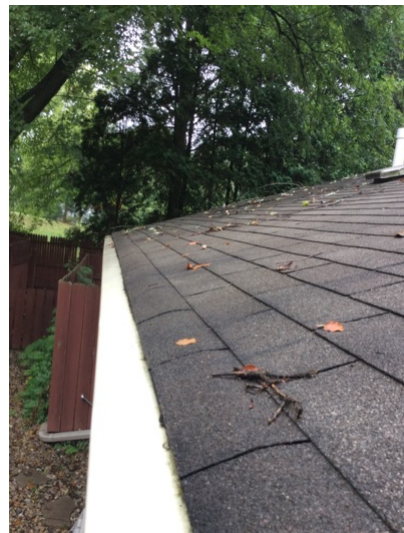
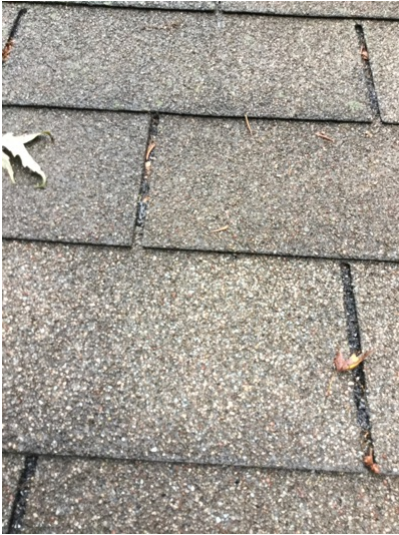
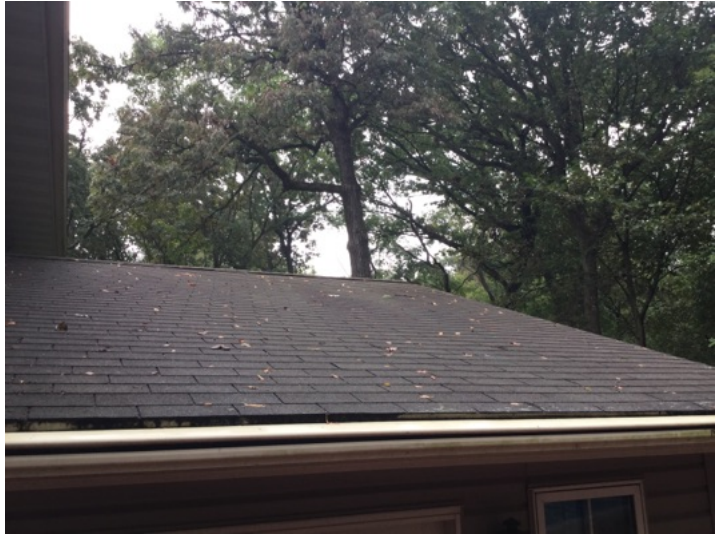
6.4. Improve: Recommend adding angled / diverter flashing to area of roof sloped towards the CHIMNEY to direct water around the chimney rather than allow water to discharge straight down the side of the chimney, which results in dirty looking streaks and which could potential cause water damage to the structure.

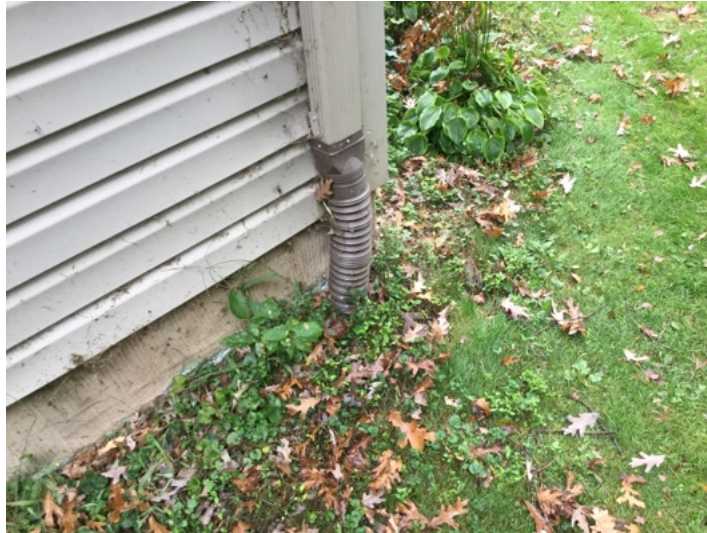
8.5. The exterior drainage is generally away from the foundation.

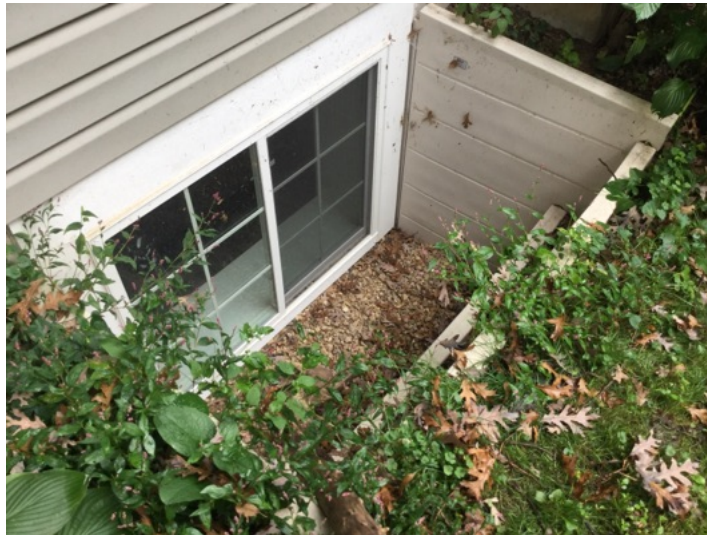
11.7. Consider installing a cover on the open egress window well to prevent someone from falling in....

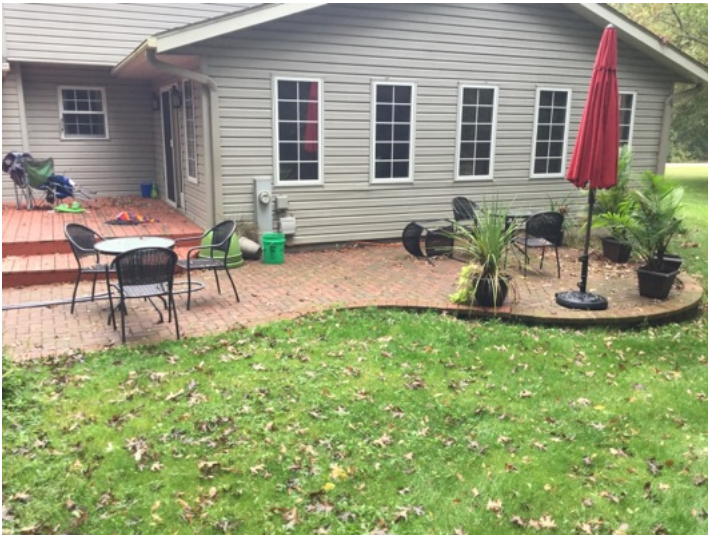
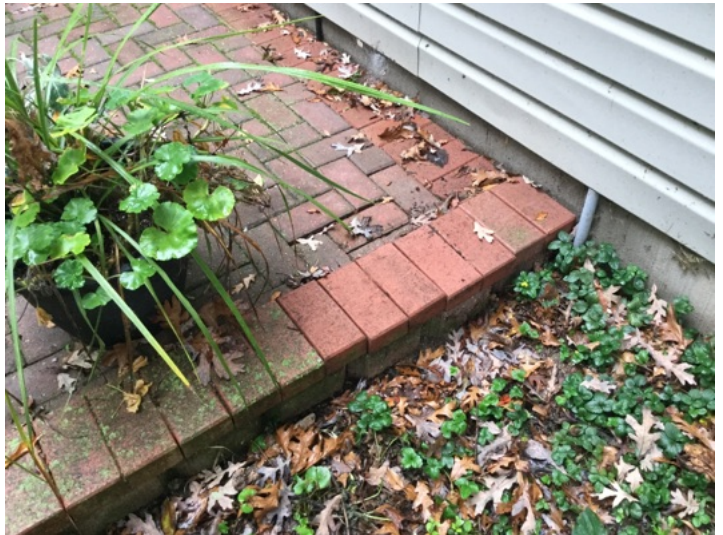
12.2. Brick or Block "Pavers" present with one of more trip hazards noted from unlevel or loose patio pavers. Recommend re-leveling / securing any such areas to prevent accidents.

loose bricks at patio were noted

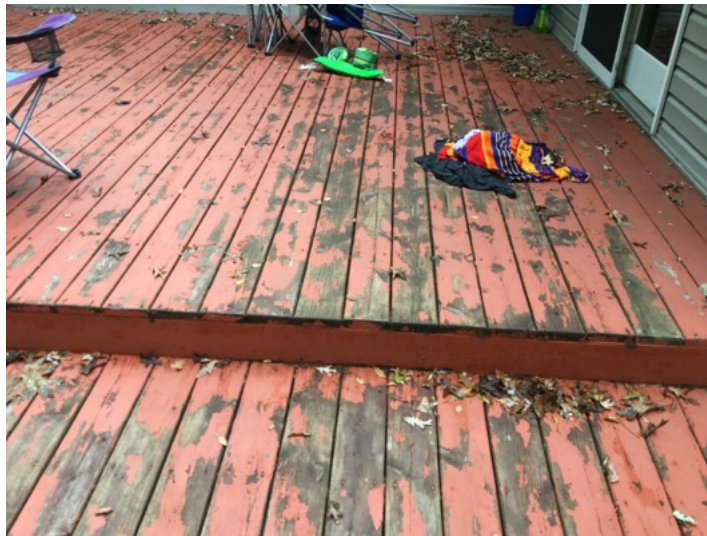
clean and seal the deck.

12.5. -Treated Lumber noted: Whether treated or not, it is important to keep a wood deck surface free of all forms of fungal growth and debris that retains moisture and will cause the deck to eventually rot. Recommend cleaning and resealing the deck annually. Cleaning can be accomplished by scrubbing the deck with a sodium-hypochlorite (bleach) and Tri-Sodium-Phosphate (TSP) deck wash and then rinsing with a pressure washer. Finally, a wood deck should be recoated with a high quality deck sealant.

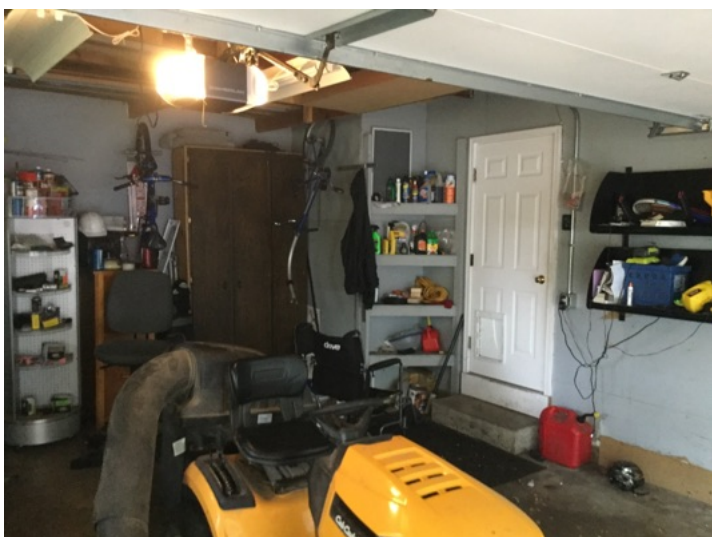
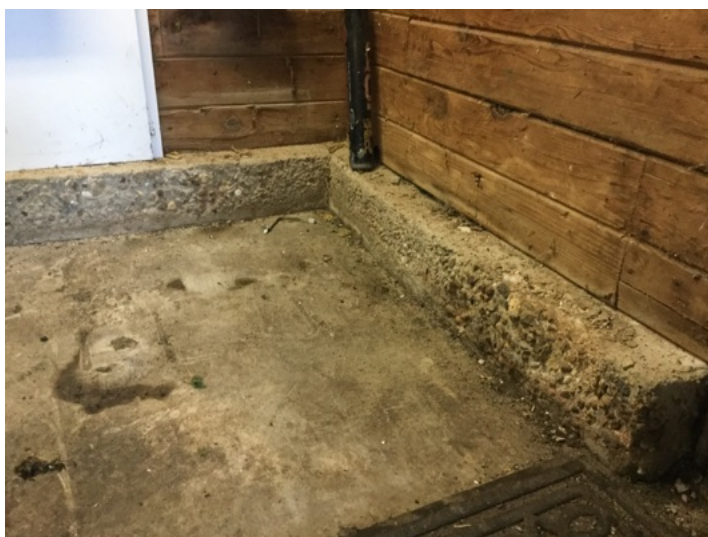
Mild Spalling (surface deterioration) was noted on the garage foundation walls. While this may not yet be a structural concern, left alone the condition will likely get worse. Spalling on concrete foundations can be the result of a number of things including, the concrete's ingredients, chemical reactions between reinforcing metal rebar in the foundation walls, chemicals stored close to the concrete, road salt, and concrete walls which were not sealed to name a few. It also is an indicator of the frequent presence of moisture near and in the wall. See additional comments in the gutter and grading section of the report. It is beyond the scope of a home inspection to identify the exact cause of spalling, what we do know though is that protecting the surface from further decay is important- consider resurfacing where needed. (Sakrete brand Top' N Bond works well for such a job- available at Farm and Fleet).

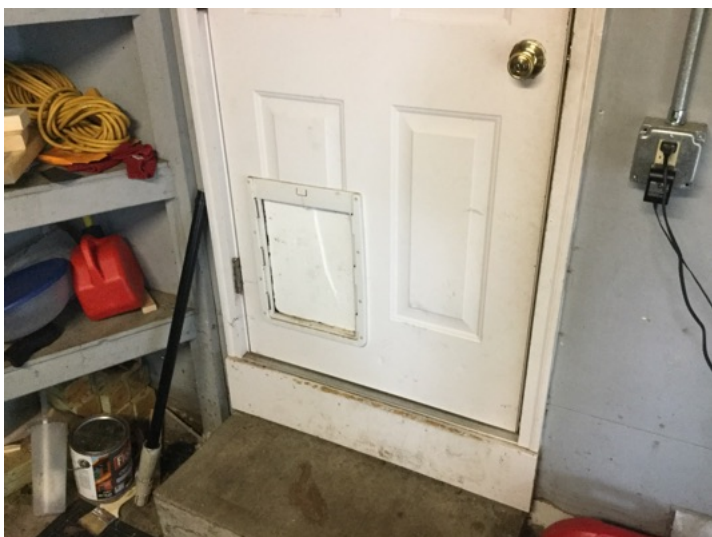
Pet Door Installed; this may compromise security or firewalls...budget for replacement door if this is a concern for you.

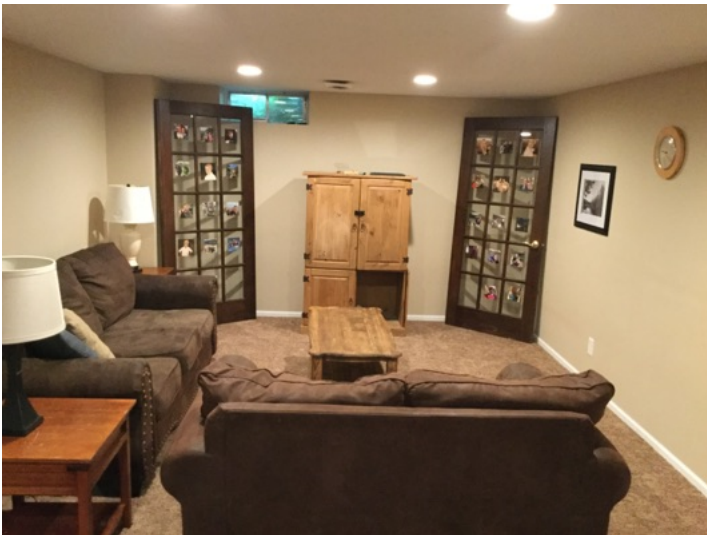
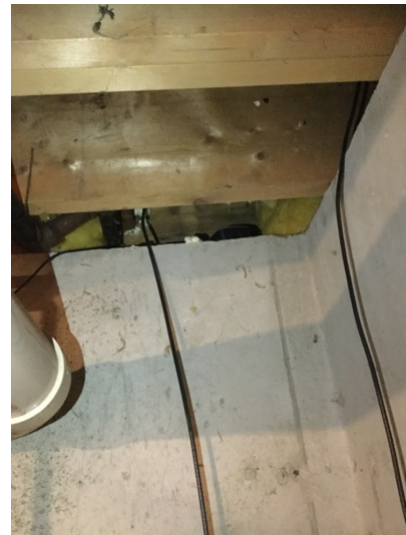
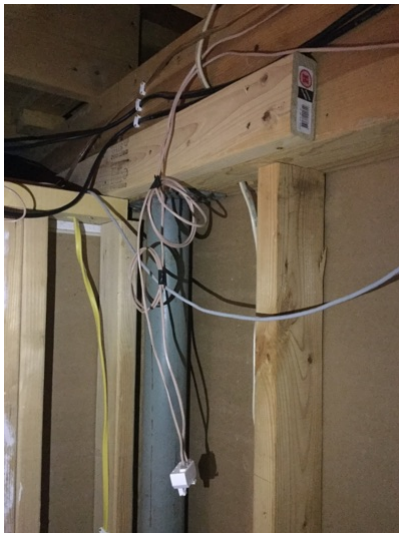
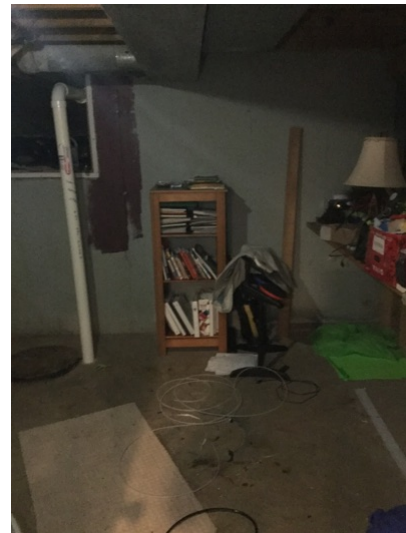
2.9. Past or Present MOUSE/Vermin activity was suspected due to waste, traps, or poison. Contact a qualified pest control contractor if condition cannot be managed.

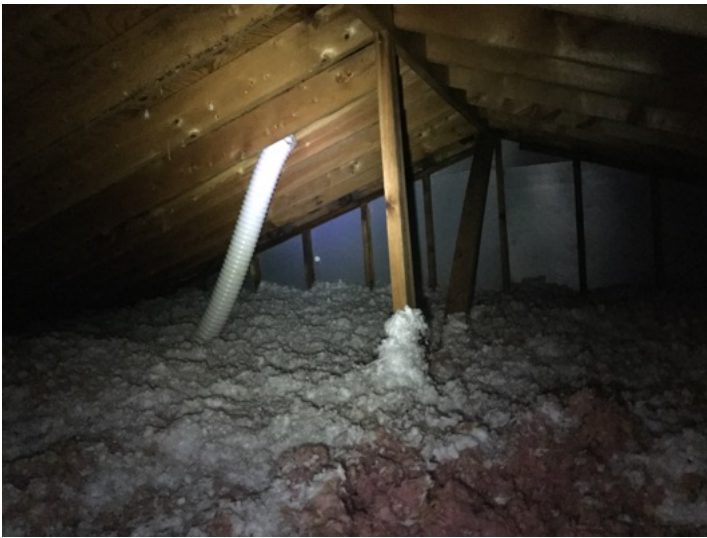
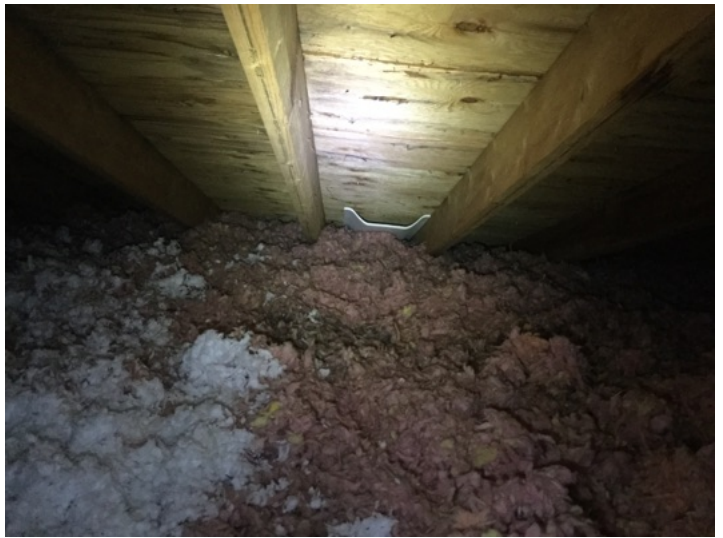
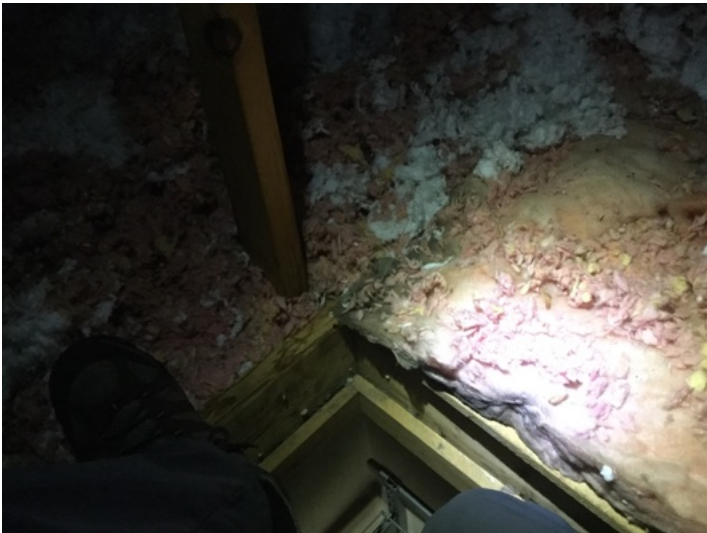
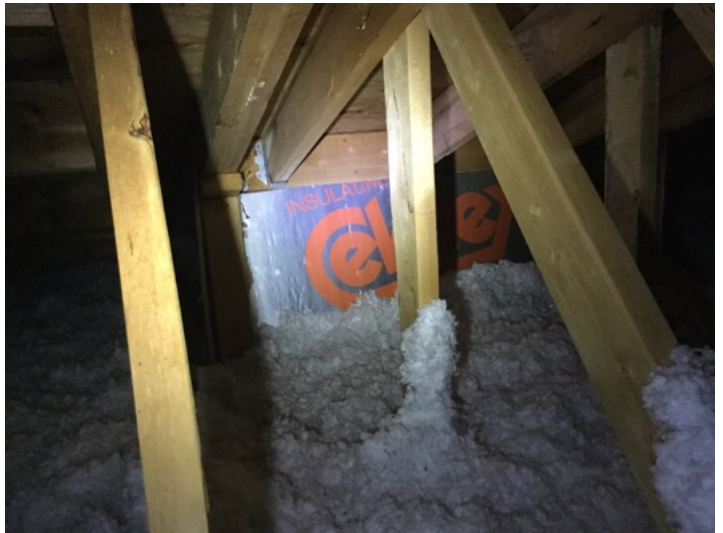
3.9. Past or present MOUSE/ vermin activity is suspected, due to waste, and or burrow holes in insulation. Recommend the use of Tom Cat or D-Con brand mouse or rat bait blocks/trays scattered around the attic to control the pests.

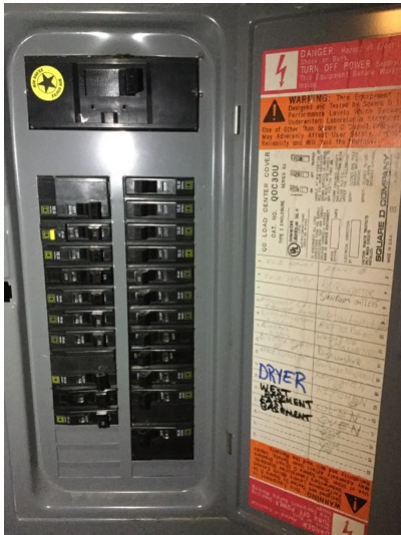
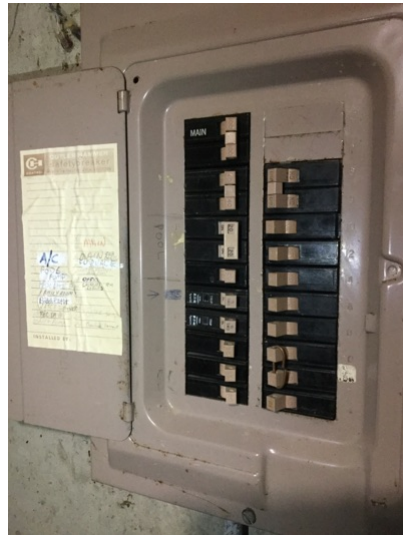
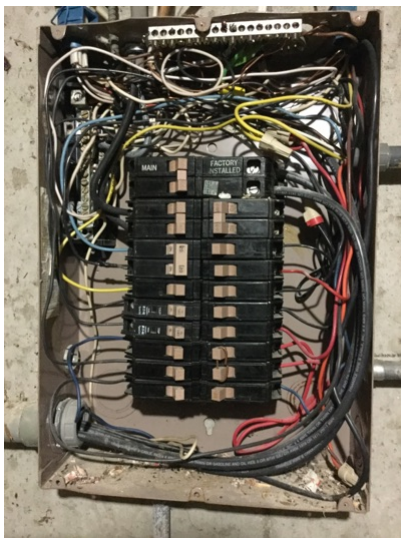
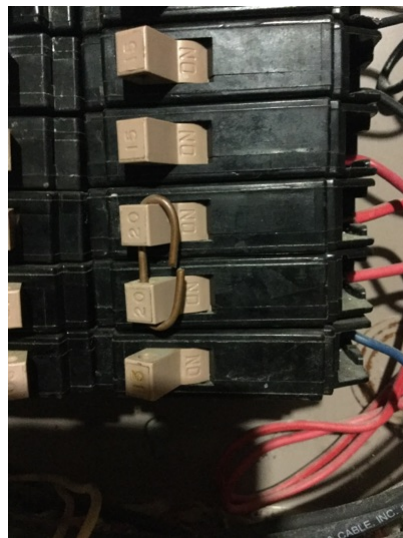
1.15. Non listed breaker tie noted in the sub panel...replace with approved tie for safety.

Non listed breaker tie noted...replace with approved tie for safety.

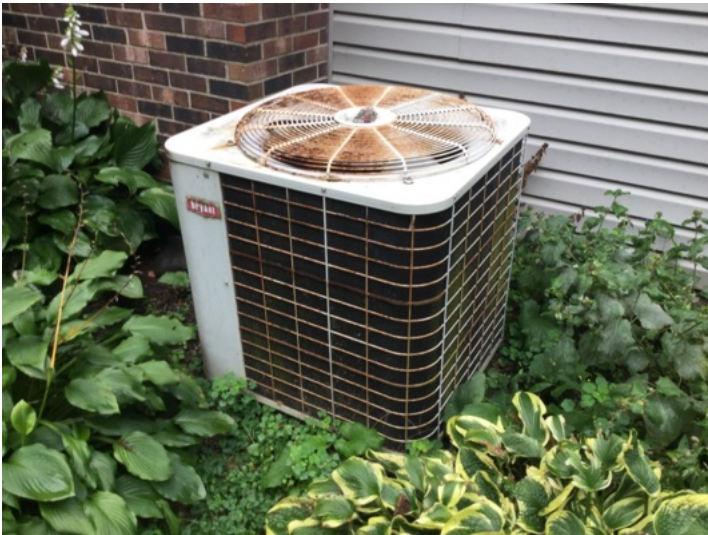
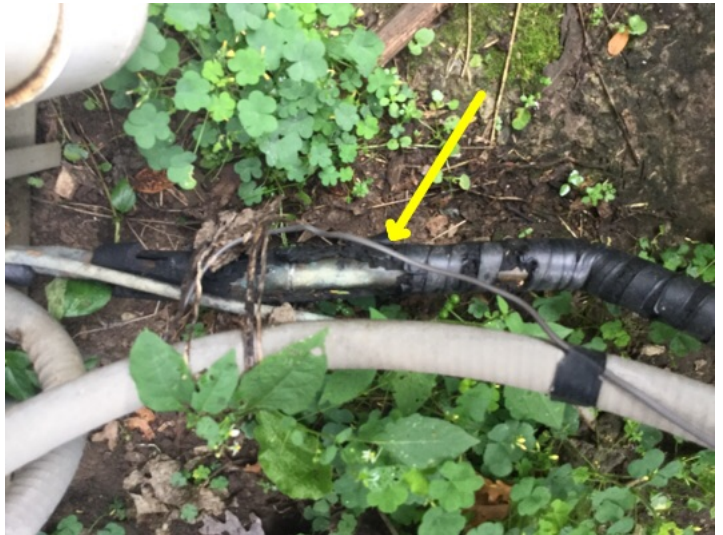
Insulation is deteriorated or missing on the suction line at exterior of house, recommend replacement of insulation to maximize the efficiency of the unit.

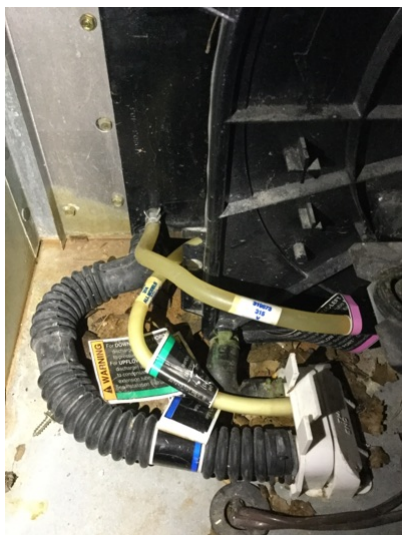
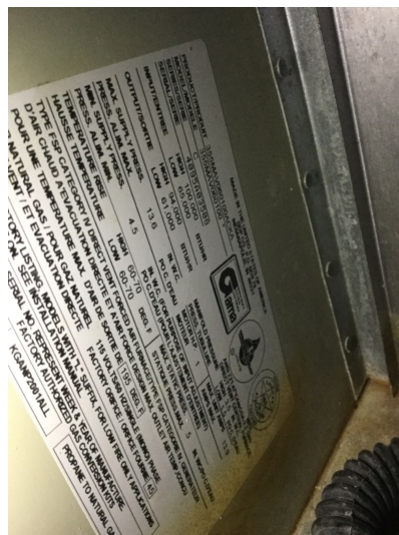
Some rust was present in the furnace cabinet where the condensate collection point inside the furnace attaches to the condensate drain line, this is likely the result of a small leak near the point of connection, monitor and tighten connections if necessary. If the issue has not already been fixed, it will be noticeable in the heating months. Consider having the furnace serviced by an HVAC specialist prior to the heating season.

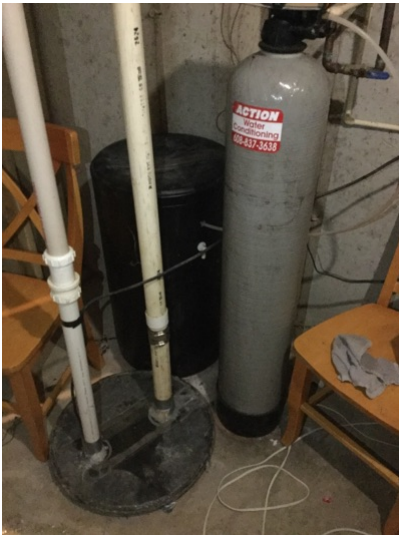
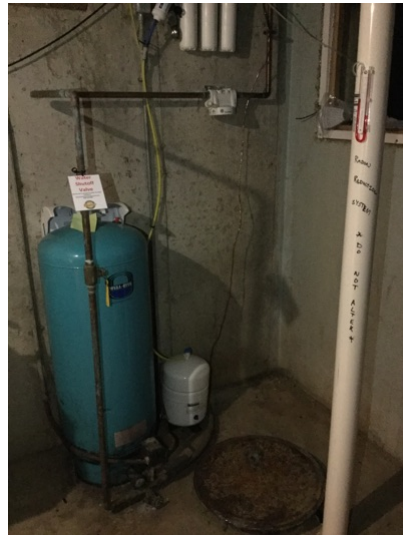
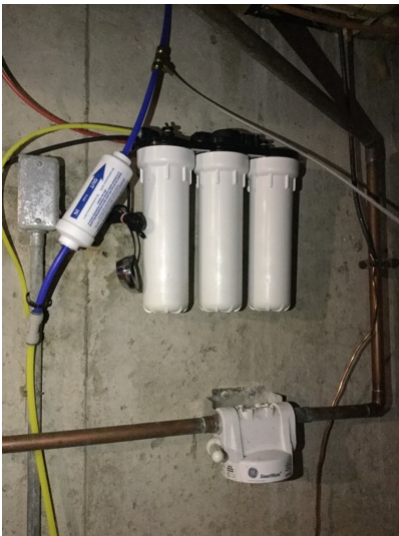
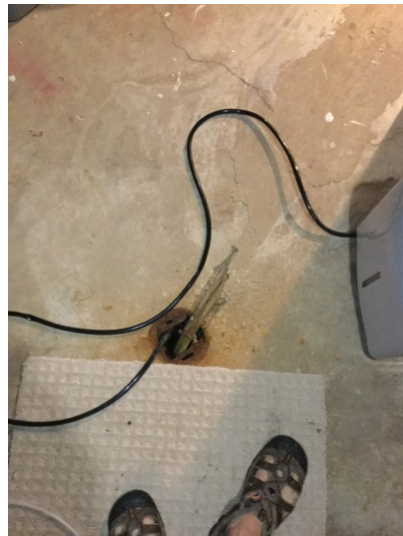
Water purification system installed, these are not tested or inspected, other than for running water at faucets (if present).

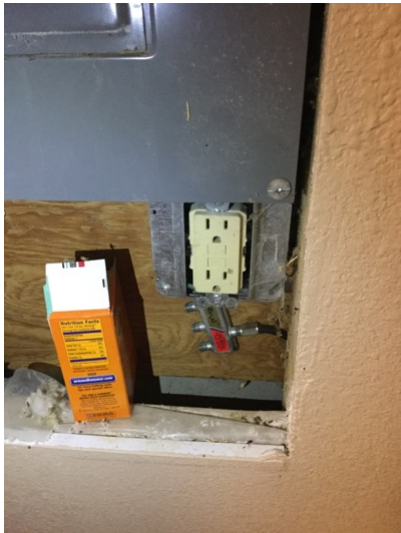
Missing switch/outlet covers noted. COVERS are necessary to prevent electrical shock- install as soon as possible.

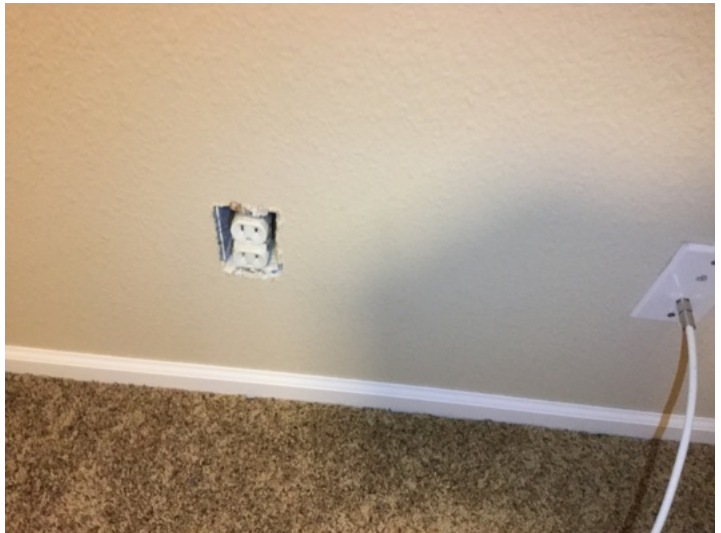
Missing switch/outlet covers noted. COVERS are necessary to prevent electrical shock- install as soon as possible.
